As you requested, one of our certified technicians has diagnosed the cause for the Check Engine Light to be illuminated on your 2002 Chevrolet Impala. The code that is present is P0420 Bank 1 Catalyst Efficiency Low.

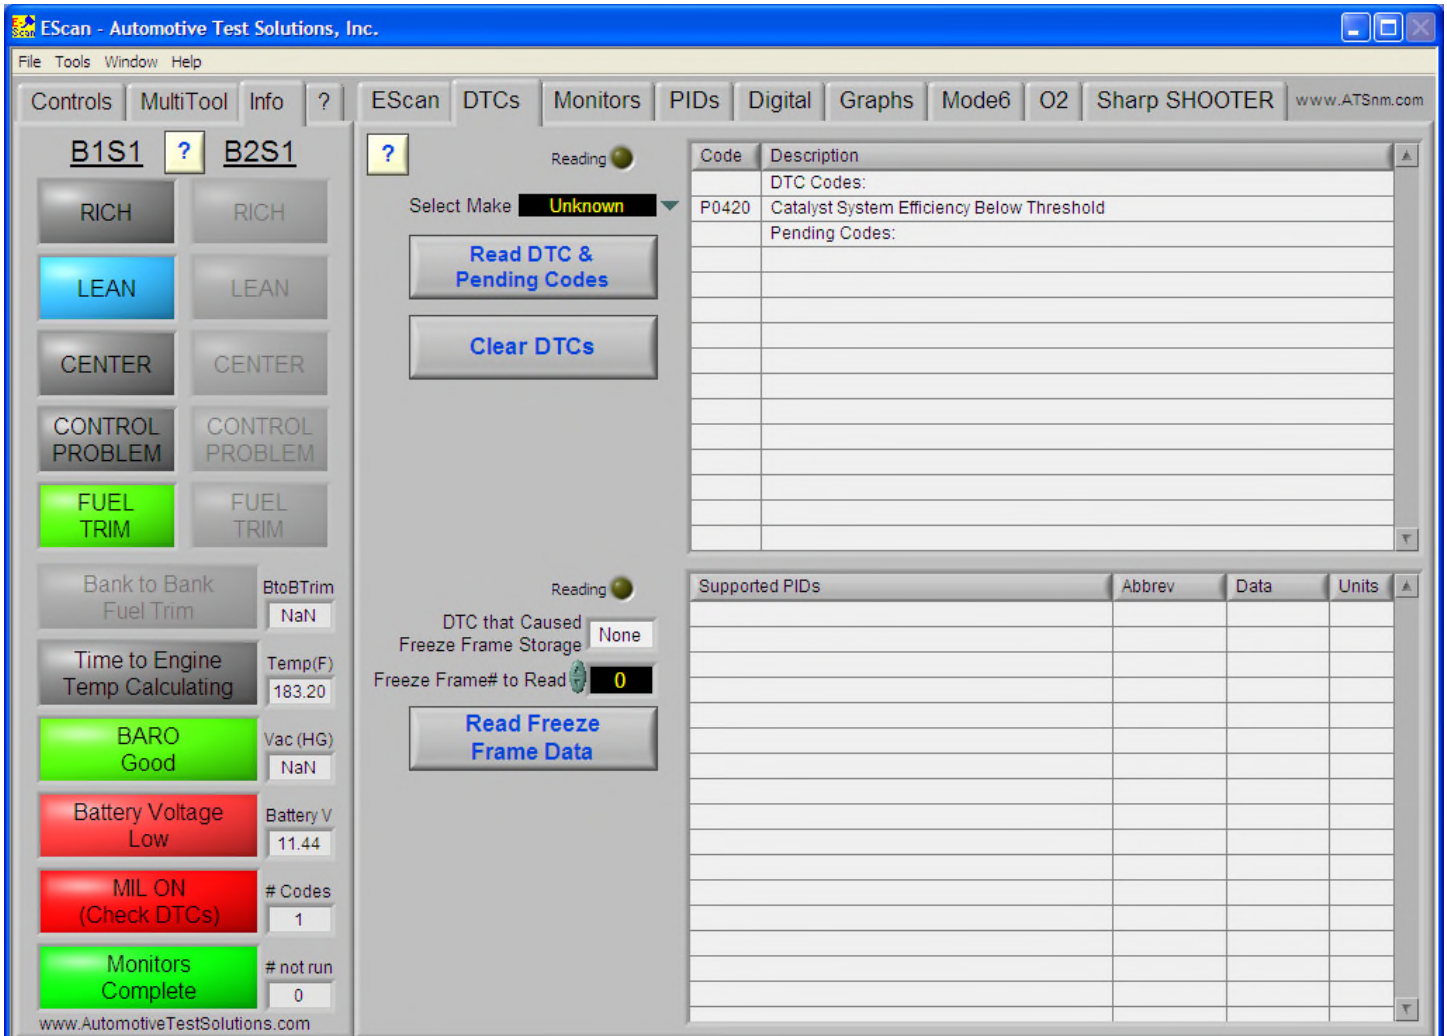
While some vehicles have multiple catalytic converters on them, yours only has one. The vehicle's on-board computer monitors various components under specified conditions, and then gives them a pass/fail result. Your catalytic converter has failed multiple times – thus the check engine light. Here is a capture using software built into one of the scan tools we use, which shows how efficiently your catalytic is working:

As you can see, the catalyst is working at roughly 66%. Typically, it should be above 80%. Our technician also noticed while testing your vehicle, that the catalytic converter has been replaced previously, with a universal catalytic converter.

As you can see, all the grids are green, indicating that the system is operating within spec at this time. We also checked for software updates to your on-board computer, and there are none at this time. So our recommendations at this time are to replace the spark plugs, spark plug wires, and install a direct-fit catalytic converter. I will be following up with a phone call, to give you an estimate, and answer any questions you may have.

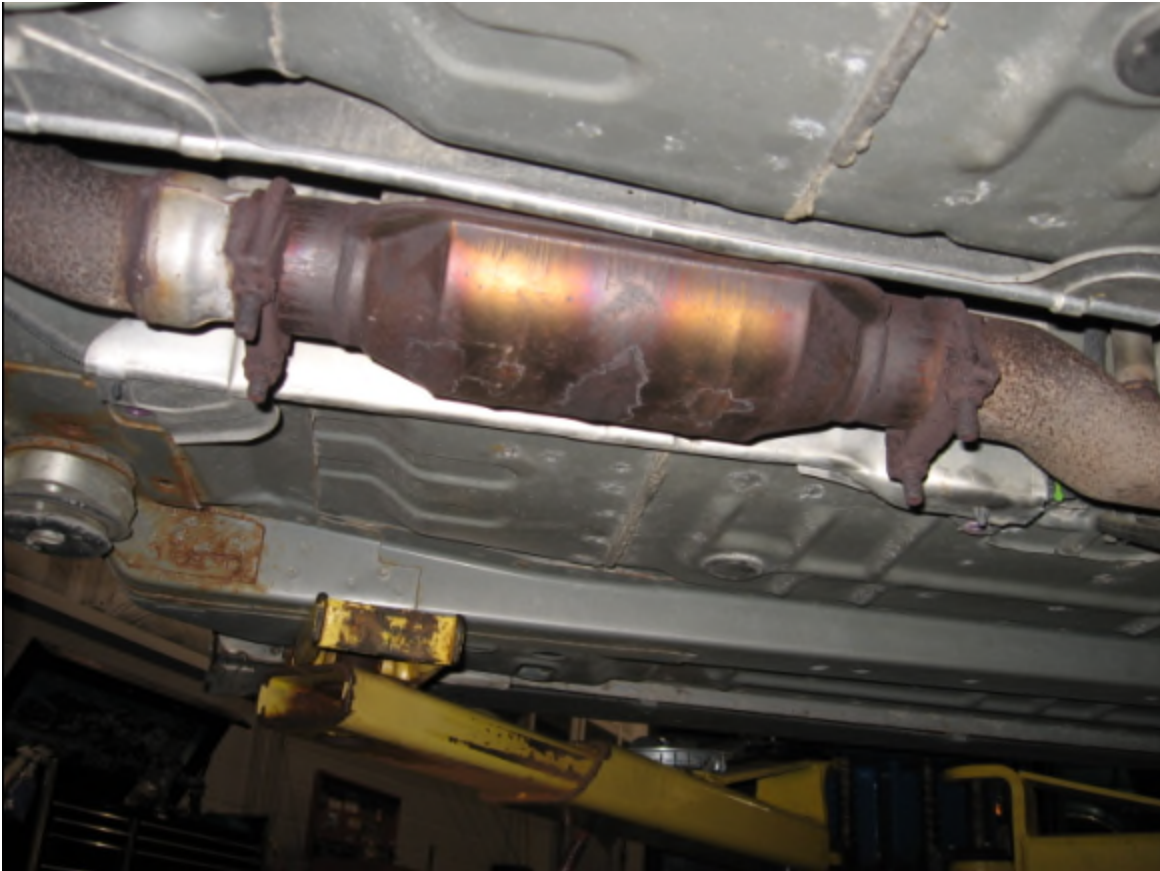
Please note the use of a reducer pipe, and the 2 exhaust clamps used, typically when the car comes from the factory, or when a direct-fit catalytic converter is used, this is all one piece. Now, I'm sure you're wondering "Why would another catalytic converter be bad on my car with 126,000 miles?". There are several answer's for this question. The first possibility is the use of the smaller, universal catalyst. Secondly, a poor running engine can damage the catalyst in a matter of minutes. The technician noted that the car has the original spark plug wires, and what seem to be the original spark plugs.

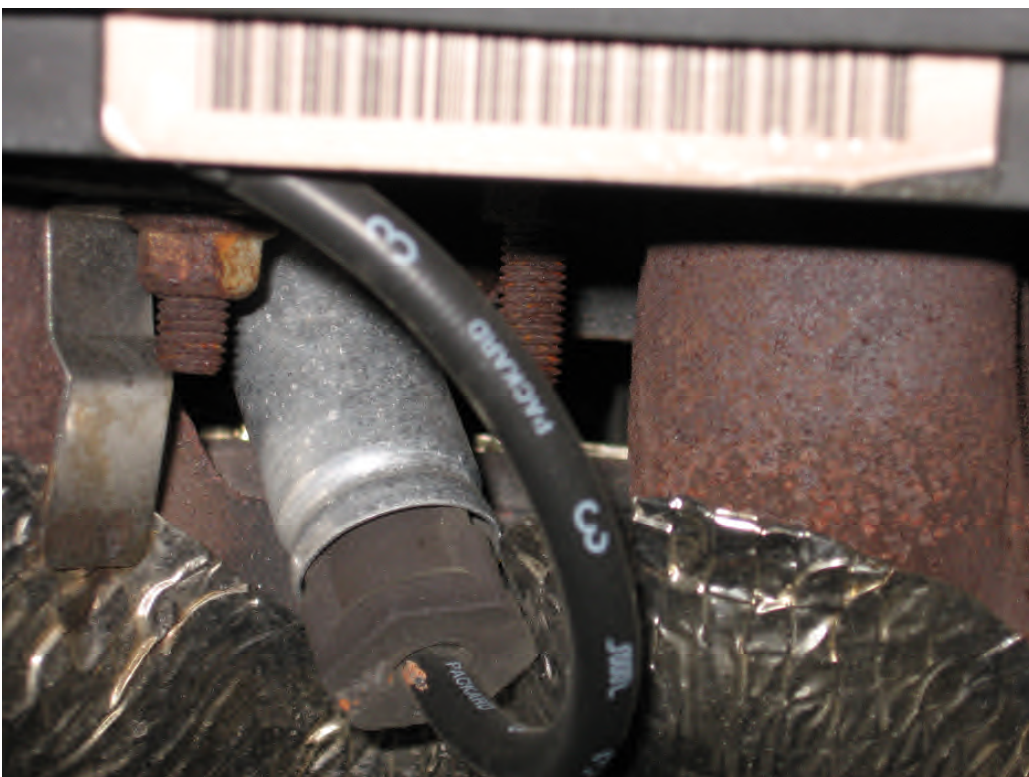
Notice the number on the spark plug wire? This is indicative that the plug wires are original. Also, if there is an error in the fuel control system of the vehicle, the catalyst may be damaged as well. Generally speaking the fuel control system is doing OK if it is adding or subtracting less than 10% of the fuel mixture. Here is a capture that the technician took while on a test drive with your car.
