Finding Tough A/C Leaks with Bullseye

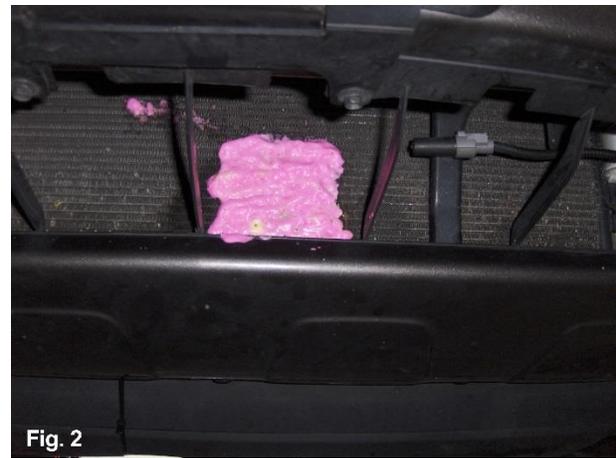
As you can see (Figure 2), the pink foam (area of no leak) reacts with the CO₂ and turns yellow, confirming the leak. A new condenser and receiver drier (one complete unit) later, and this customer's problem was solved!

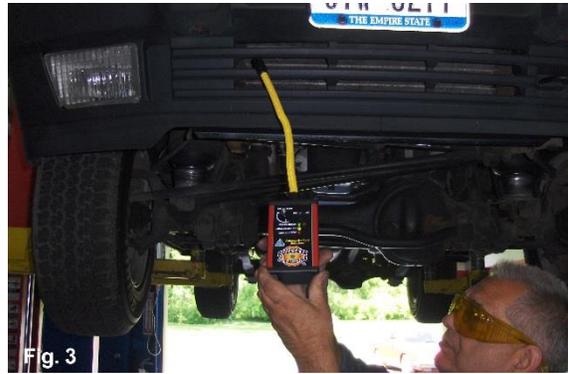
Fig. 3

The example is a 1996 Land Rover Range SE 4.0L Leaking AC System that was a breeze to find with the ATS BullsEye A/C detection system. Since this came from another shop that had already looked for a leaks we did not waste any time looking for a leak with dye or any other system except BullsEye. As you can see by the picture (Fig. 3) I took a picture of Jimmy locating the area of the leak and when the ATS detector located the area I sprayed the magic form. There was no question on where the leak was coming from. Take a look at (Fig. 4 & 5) were the leak was coming from the area turned yellow. Returned the vehicle to the shop where the replaced the condenser, receiver drier and charged the system now the vehicle was now fixed. Air conditioning leaks can be very frustrating, however with new techniques and the right equipment these problems can be solved quickly and easily.
